Lenovo NeXtScale nx360 M4 Installation and Service Guide

Machine Type: 5455

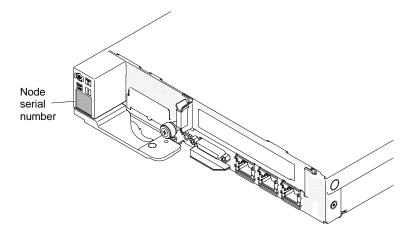
Figure 1. NeXtScale nx360 M4 compute node

The model number and serial number are on the ID label on the bezel on the front of the compute node, and on a label on the bottom of the compute node that is visible when the compute node is not in the Lenovo NeXtScale n1200 Enclosure. If the compute node comes with an RFID tag, the RFID tag covers the ID label on the bezel on the front of the compute node, but you can open the RFID tag to see the ID label behind it.

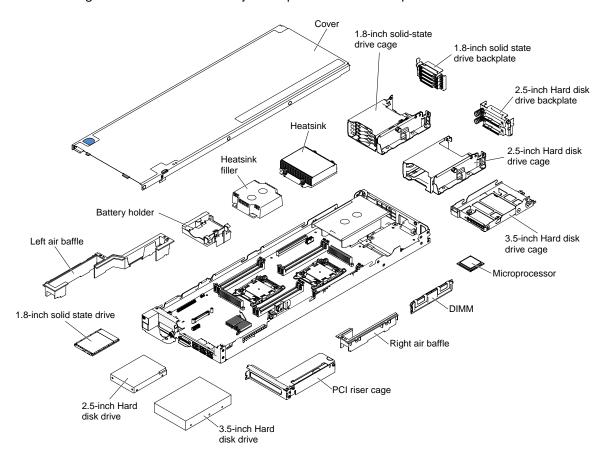
Figure 3. Major components of the compute node

The following illustration shows the major components of the compute node.

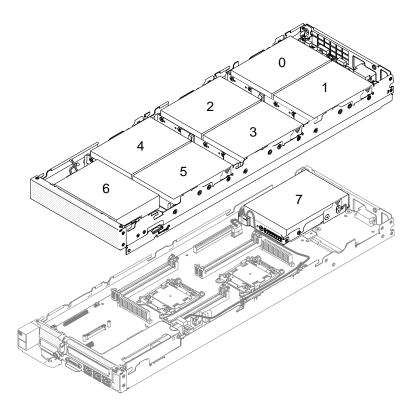
Figure 4. Major components of the storage tray

The ServeRAID adapter can be connects from compute node via PCIe interface to support RAID level-0, RAID level-1, RAID level-5, or RAID level-10.

The following illustration shows the major components of the storage tray.

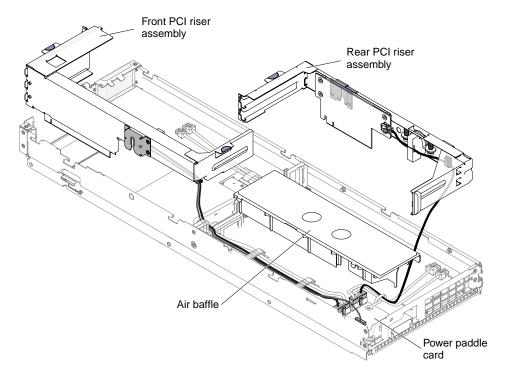
Figure 5. Major components of the GPU tray

The GPU tray is installed on the top of a compute node. Each GPU tray supports up to two Graphics Processing Unit (GPU) enclosure (full-height, full-length).

The following illustration shows the major components of the GPU tray.

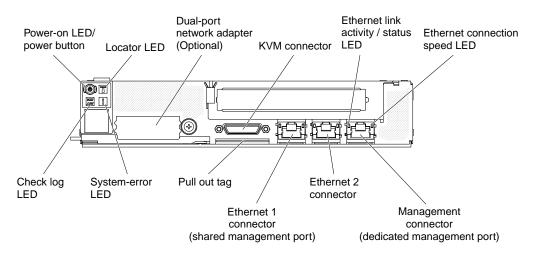
Figure 6. Compute node control panel buttons, connectors, and LEDs

The following illustration identifies the buttons, connectors, and LEDs on the control panel.

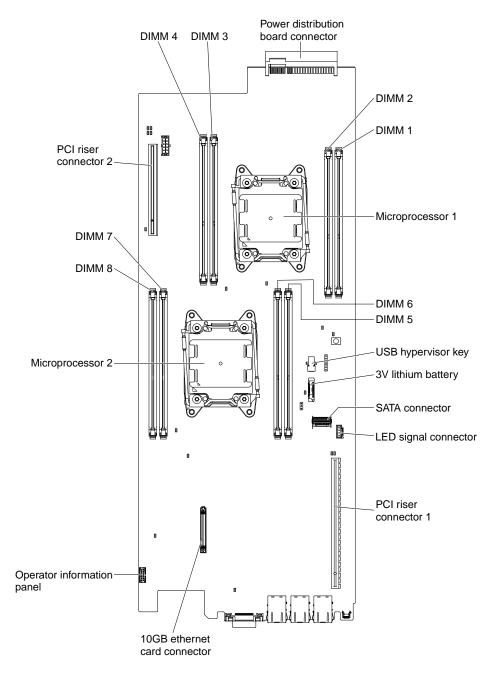
Figure 8. Internal connectors on system board

The following illustrations show the internal connectors on the system board.

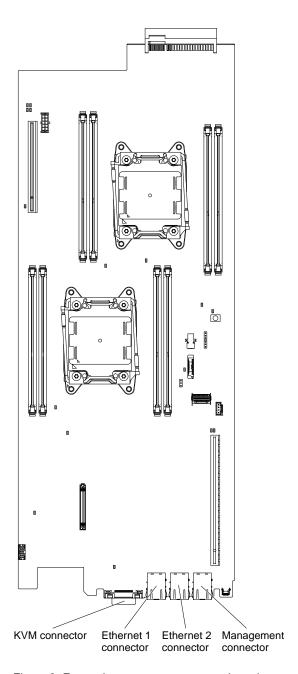
Figure 9. External connectors on system board

The following illustration shows the external connectors on the system board.

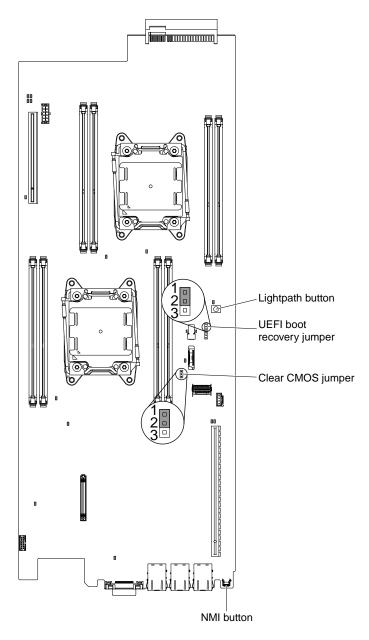
Figure 10. Location and description of switches and jumpers

The following illustration shows the location and description of the switches and jumpers.

Note: If there is a clear protective sticker on the top of the switch blocks, you must remove and discard it to access the switches.

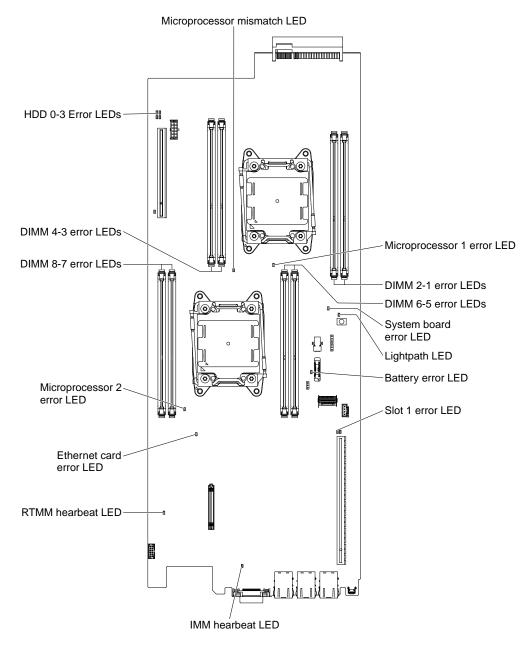
Figure 11. LEDs and controls on system board

Any error LED can be lit after ac power has been removed from the system-board tray so that you can isolate a problem. After ac power has been removed from the system-board tray, power remains available to these LEDs for up to 90 seconds. To view the error LEDs, press and hold the light path button on the system board to light the error LEDs. The error LEDs that were lit while the system-board tray was running will be lit again while the button is pressed.

The following illustration shows the LEDs and controls on the system board.

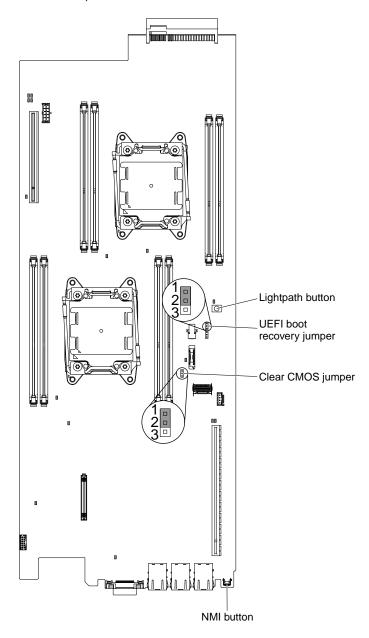
Figure 12. Power-on password switch

- Remove the battery from the server, wait 30 seconds, and then reinstall it.
- Change the position of the power-on password switch (enable switch 3 of the system board switch block (SW4) to bypass the password check (see "System-board switches and jumpers" on page 17 for more information).

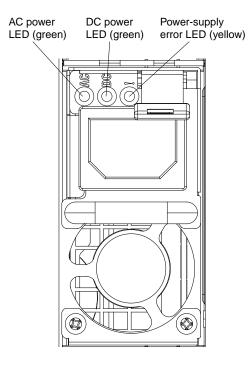
Figure 14. AC power-supply LEDs

Note: You must turn on the server for the DC LED on the power supply to be lit.

The following illustration shows the locations of the power-supply LEDs on the ac power supply.

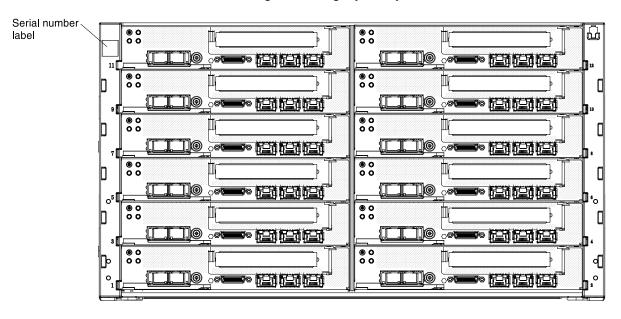
Figure 15. ID label

The model name and serial number are located on the ID label on the front of the server as shown in the following illustration.

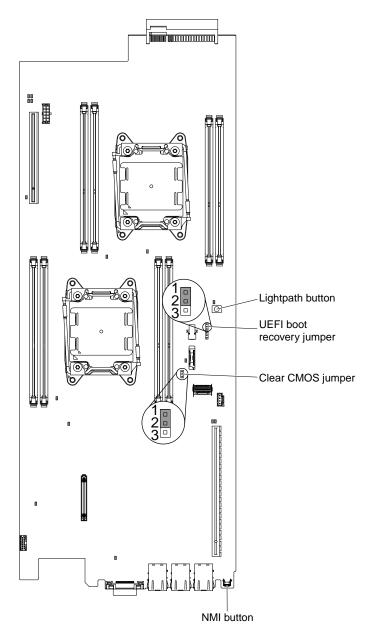
Figure 16. UEFI boot backup jumper (JP2) location

- Step 1. Read the safety information that begins on "Safety" on page v and "Installation guidelines" on page 111.
- Step 2. Turn off the server, and disconnect all power cords and external cables.
- Step 3. Remove the cover (see "Removing the compute node cover" on page 127).
- Step 4. Locate the UEFI boot backup jumper (JP2) on the system board.

- Step 5. Move the UEFI boot backup jumper (JP2) from pins 1 and 2 to pins 2 and 3 to enable the UEFI recovery mode.
- Step 6. Reinstall the server cover; then, reconnect all power cords.
- Step 7. Restart the server. The system begins the power-on self-test (POST).
- Step 8. Boot the server to an operating system that is supported by the firmware update package that you downloaded.
- Step 9. Perform the firmware update by following the instructions that are in the firmware update package readme file.
- Step 10. Turn off the server and disconnect all power cords and external cables, and then remove the cover (see "Removing the compute node cover" on page 127).
- Step 11. Move the UEFI boot backup jumper (JP2) from pins 2 and 3 back to the primary position (pins 1 and 2).

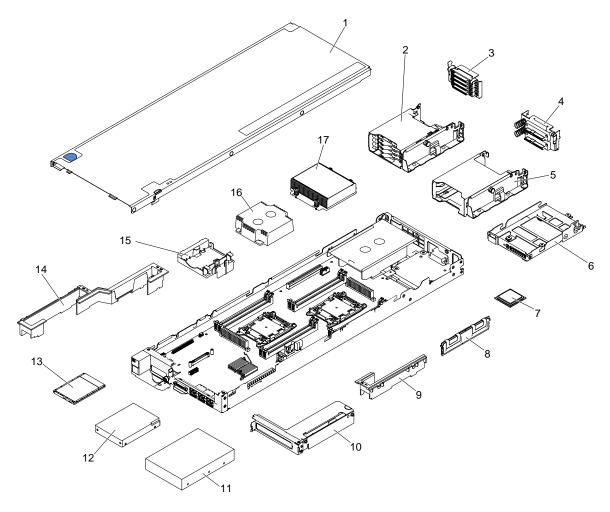
Figure 17. Server components

The following illustration shows the major components in the server. The illustrations in this document might differ slightly from your hardware. For a list of structural parts, see "Structural parts" on page 107.

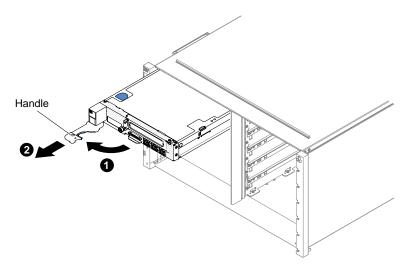
Figure 18. Removal of a NeXtScale nx360 M4 compute node from a chassis

Step 1. Open the front handle as shown in the illustration. The compute node moves out of the node bay approximately 0.6 cm (0.25 inch).

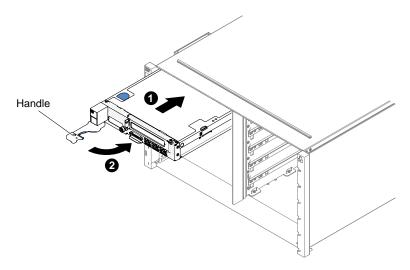
Figure 19. Installing the compute node in a Lenovo NeXtScale n1200 Enclosure

To install the compute node in a chassis, complete the following steps.

Step 1. Select the node bay.

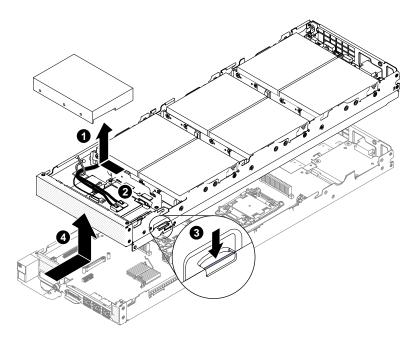
Figure 20. Removal of a storage tray

- Remove the easy-swap hard disk drive #6 (see "Removing a 3.5-inch hard disk drive" on page Step 1. 162).
- Disconnect the configuration cable, the hardware RAID (signal) cable, and the mini-SAS cable from Step 2. the storage tray.
- Step 3. Press on the release latch and slide the storage tray toward the rear of the compute node.

Step 4. Pull the storage tray out of the compute node.

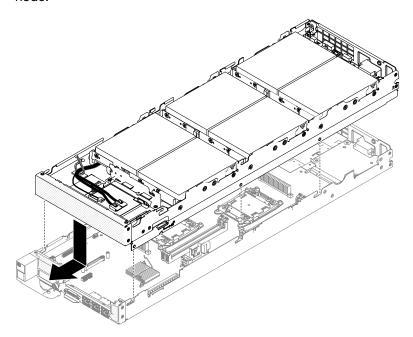
Figure 21. Storage tray installation

- Step 1. Carefully lay the storage tray on a flat, static-protective surface, orienting the storage tray with the release latch near your right hand side.
- Step 2. Connect the configuration cable, the hardware RAID (signal) cable, and the mini-SAS cable to the storage tray.
- Step 3. Install the easy-swap hard disk drive #6 (see "Installing a 3.5-inch hard disk drive" on page 163).
- Step 4. Orient the storage tray so that the posts on the inside of the storage tray slide into the slots on the compute node.

Step 5. Hold the front of the compute node and slide the storage tray forward to the closed position, until it clicks into place.

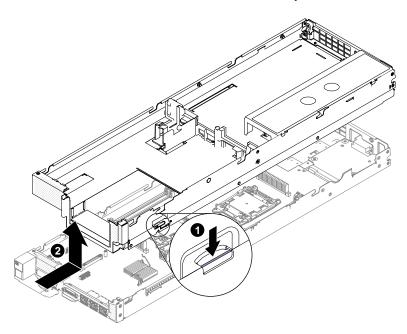
Figure 22. Removal of a GPU tray

- Step 1. Remove the cover (see "Removing the compute node cover" on page 127).
- Step 2. Remove the PCI riser-cage assembly in the GPU tray (see "Removing a PCI riser-cage assembly in the GPU tray" on page 172).
- Step 3. Press on the release latch and slide the GPU tray toward the rear of the compute node.

Step 4. Pull the GPU tray out of the compute node.

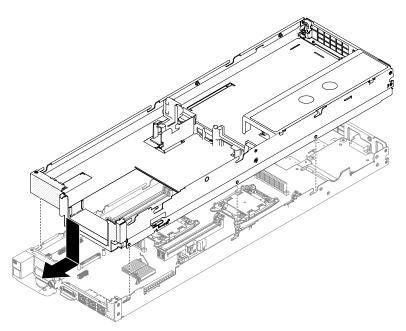
Figure 23. GPU tray installation

- Step 1. Carefully lay the GPU tray on a flat, static-protective surface, orienting the GPU tray with the release latch near your right hand side.
- Step 2. Connect the cables that were disconnected from the GPU tray.
- Step 3. Orient the GPU tray so that the posts on the inside of the GPU tray slide into the slots on the compute node.

- Step 4. Hold the front of the compute node and slide the GPU tray forward to the closed position, until it clicks into place.
- Step 5. Reinstall the PCI riser-cage assembly in the GPU tray (see "Replacing a PCI riser-cage assembly in the GPU tray" on page 174).
- Step 6. Replace the cover (see "Installing the compute node cover" on page 129).

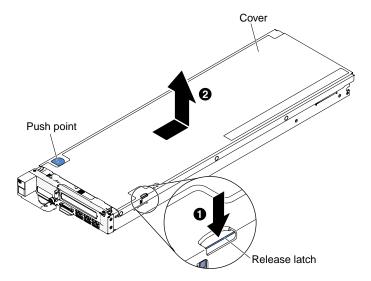
Figure 24. Remove the compute node cover

- Step 1. Press on the release latch and the push point at the same time and slide the cover toward the rear of the compute node.
- Step 2. Lift the cover away from the compute node.

Attention: Do not use any tools or sharp objects to press on the release latch. Doing so might result in permanent damage to the release latch.

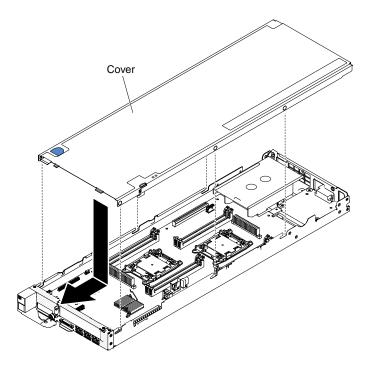
Figure 25. Installing the compute node cover

- Step 1. Carefully lay the compute node on a flat, static-protective surface, orienting the compute node with the bezel pointing toward you.
- Step 2. Orient the cover so that the posts on the inside of the cover slide into the slots on the compute node.

Step 3. Hold the front of the compute node and slide the cover forward to the closed position, until it clicks into place.

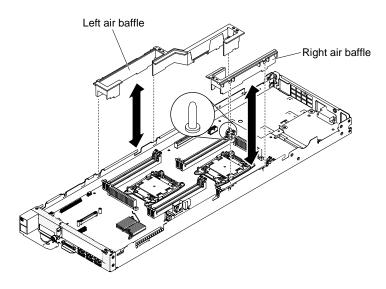
Figure 26. Air baffle removal (compute node)

- Step 1. Read the safety information that begins on "Safety" on page v and "Installation guidelines" on page 111.
- Step 2. Turn off the compute node and peripheral devices and disconnect the power cords and all external cables (see "Turning off the compute node" on page 15).
- Step 3. Remove the cover (see "Removing the compute node cover" on page 127).
- Step 4. Grasp the air baffle, disengage pins from pin holes; then, lift the air baffle up.

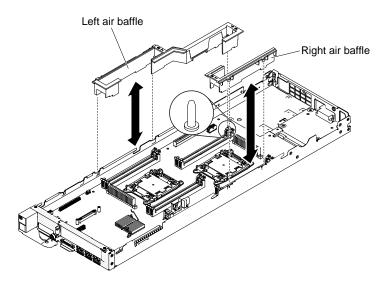
Figure 28. Air baffle installation (compute node)

Step 4. Align the air baffle pins with the baffle pin holes on the left hand side of the chassis for the left air baffle; then, lower the air baffles into the compute node. Press the air baffles down until it is securely seated.

Note: Close the retaining clip on each end of the DIMM connector before installing the air baffle for proper cooling.

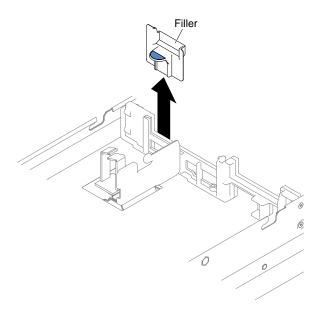
Figure 34. Filler removal

- Step 1. Read the safety information that begins on "Safety" on page v and "Installation guidelines" on page
- Step 2. Turn off the compute node and peripheral devices and disconnect the power cords and all external cables (see "Turning off the compute node" on page 15).
- Step 3. Remove the cover (see "Removing the compute node cover" on page 127).
- Step 4. Press on the touch point of the filler and lift the filler up.

Step 5. Remove the filler from the GPU tray and set it aside.

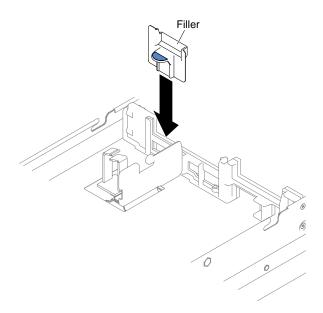
- Step 1. Read the safety information that begins on "Safety" on page v and "Installation guidelines" on page 111.
- Step 2. Turn off the compute node and peripheral devices and disconnect the power cords and all external cables.
- Step 3. Remove the cover (see "Removing the compute node cover" on page 127).
- Step 4. Align the filler with the bracket on the middle of the GPU tray; then, lower the filler into the GPU tray. Press the filler down until it is securely seated.

Figure 35. Filler installation

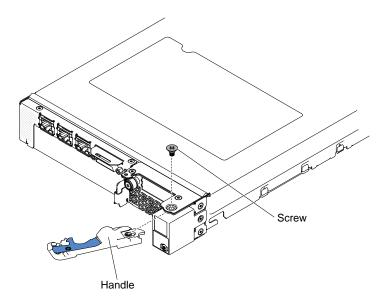
Figure 36. Removal of the front handle

- Step 1. Locate the screw that attaches the handle to the compute node.
- Step 2. Using a Phillips screwdriver, remove the screw from the front handle and save the screw in a safe place. Use the same screw when you install a front handle.

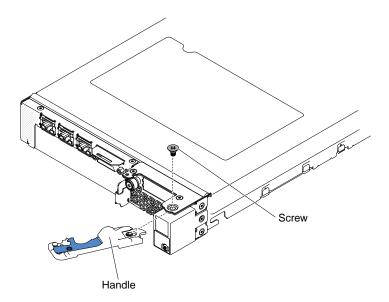
Figure 37. Installation of the front handle

- Step 1. Orient the front handle so that the blue release latch is toward the middle of the compute node.
- Step 2. Align the hole in the handle with the hole on the compute node where the handle is installed.
- Step 3. Using a Phillips screwdriver, install the Phillips #2 screw that secures the handle. Install the screw that you removed when you removed the handle.

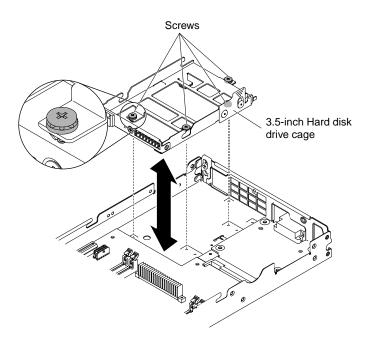
Figure 38. Removing a hard disk drive cage (3.5-inch)

- Step 1. Remove the cover (see "Removing a compute node from a chassis" on page 114).
- Step 2. Remove the easy-swap hard disk drives and hard disk drive bay fillers (see "Removing and installing drives" on page 162).
- Step 3. Remove the hard disk drive backplate (see "Removing the hard disk drive backplate" on page 159).
- Step 4. Using a Phillips (for 3.5-inch hard disk drive cage) T8 torx (for 2.5-inch or 1.8-inch hard disk drive cage, provided on the back of the chassis) screwdriver, remove the screws (four for 2.5-inch hard disk drive cage and three for 1.8-inch hard disk drive cage) from the cage and rotate the cage from under the bezel; then, remove the cage from the compute node at an angle.

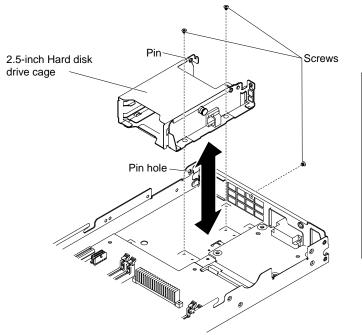
Figure 39. Removing a hard disk drive cage (2.5-inch)

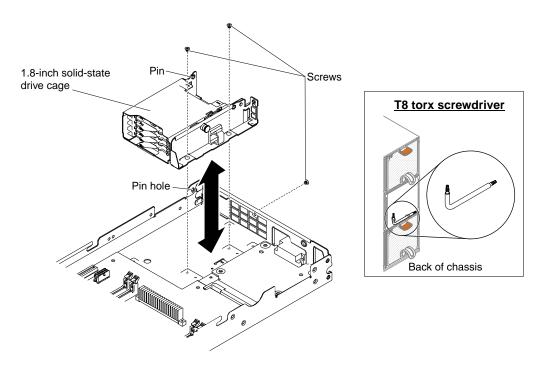
Figure 40. Removing a hard disk drive cage (1.8-inch)

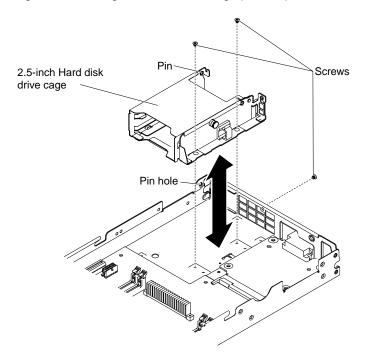
Figure 42. Installing a hard disk drive cage (2.5-inch)

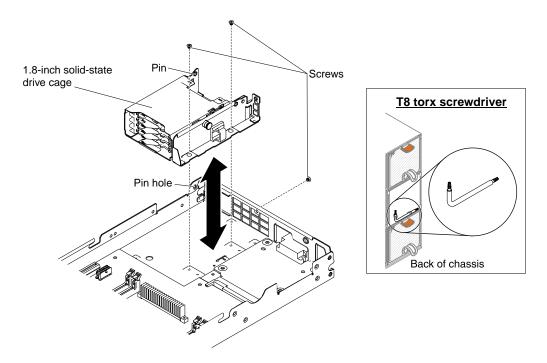
Figure 43. Installing a hard disk drive cage (1.8-inch)

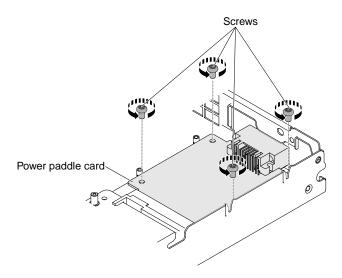
- Step 1. Read the safety information that begins on "Safety" on page v and "Installation guidelines" on page 111.
- Step 2. Turn off the compute node and peripheral devices and disconnect the power cords and all external cables (see "Turning off the compute node" on page 15).
- Step 3. Remove the cover (see "Removing the compute node cover" on page 127).
- Step 4. Remove the air baffle (see "Removing the air baffle" on page 130).
- Step 5. Make a note of where cables are attached to the power paddle card; then, disconnect them.
- Step 6. Remove the four screws that secure the power paddle card to the GPU tray and save them for future use.
- Step 7. Slide the power paddle card out of the GPU tray.

Figure 52. Power paddle card removal

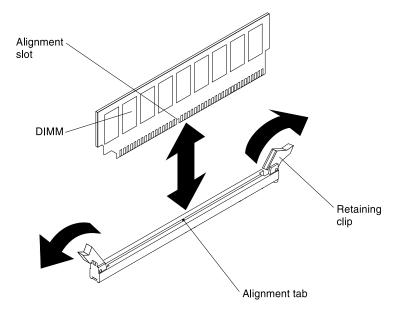
- Step 2. Turn off the server and peripheral devices and disconnect all power cords.
- Step 3. Remove the cover (see "Removing the compute node cover" on page 127).
- Step 4. Remove the air baffle (see "Removing the air baffle" on page 130).
- Step 5. Carefully open the retaining clips on each end of the DIMM connector and remove the DIMM.

Figure 56. DIMM removal

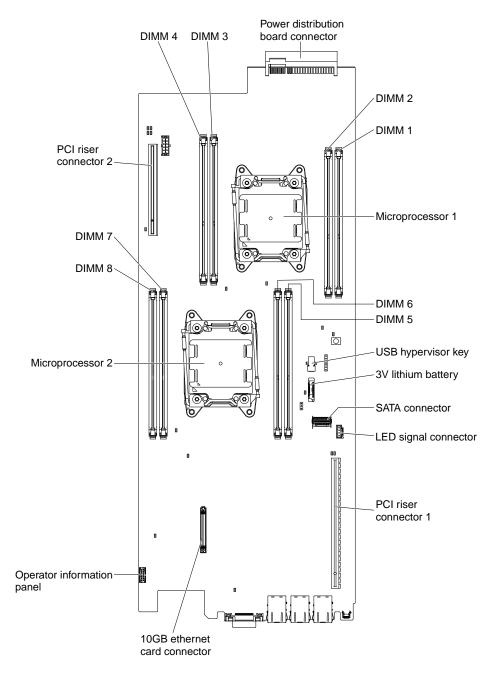
The following illustration shows the location of the DIMM connectors on the system board.

Figure 57. DIMM connectors location

- 1. You can install DIMMs for microprocessor 2 as soon as you install microprocessor 2; you do not have to wait until all of the DIMM slots for microprocessor 1 are filled.
- 2. DIMM slots 5-8 are reserved for microprocessor 2; thus, DIMM slots 5-8 are enabled when microprocessor 2 is installed.

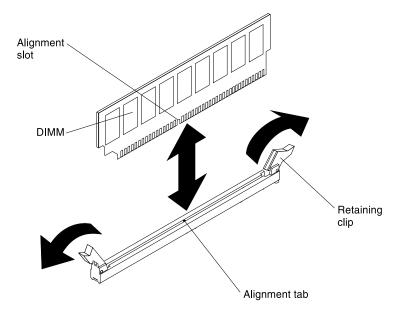
Figure 58. DIMM installation

- Step 6. Touch the static-protective package that contains the DIMM to any unpainted metal surface on the outside of the server. Then, remove the DIMM from the package.
- Step 7. Turn the DIMM so that the alignment slot align correctly with the alignment tab.
- Step 8. Insert the DIMM into the connector by aligning the edges of the DIMM with the slots at the ends of the DIMM connector.
- Step 9. Firmly press the DIMM straight down into the connector by applying pressure on both ends of the DIMM simultaneously. The retaining clips snap into the locked position when the DIMM is firmly seated in the connector.

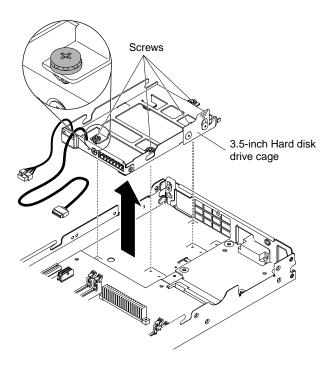
Figure 59. Removing a 3.5-inch hard disk drive hardware RAID cage

- Step 1. Remove the cover (see "Removing the compute node cover" on page 127).
- Disconnect the power cable and the mini-SAS cable from the system-board and the storage tray Step 2. respectively (see "Cabling hard disk drive with ServeRAID SAS/SATA controller" on page 195).

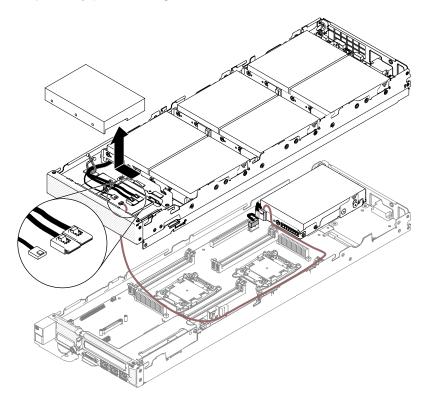
Figure 60. Disconnect the mini-SAS cable from the storage tray

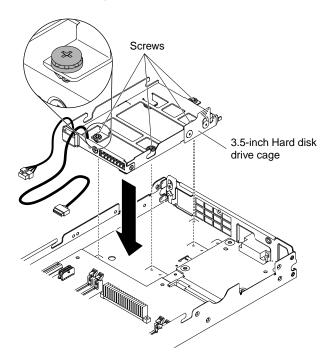
Figure 61. Installing a 3.5-inch hard disk drive hardware RAID cage

- Step 1. Remove the cover (see "Removing the compute node cover" on page 127).
- Step 2. Position the hardware RAID cage in the bezel at an angle and rotate the cage into position on the system board.
- Step 3. Align the cage with the screw holes on the system board.
- Step 4. Using a Phillips screwdriver, insert the 4 screws and secure the cage in the compute node.
- Step 5. Install the easy-swap hard disk drive #7 (see "Installing a 3.5-inch hard disk drive" on page 163).

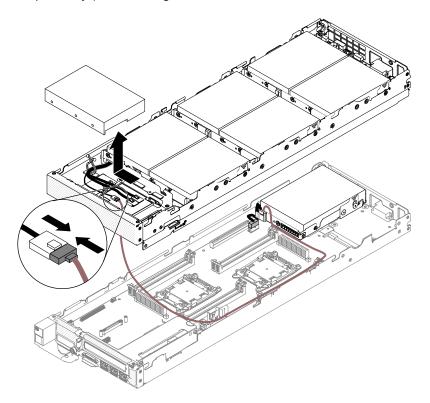
Step 6. Connect the power cable and the mini-SAS cable on the system-board and the storage tray respectively (see "Cabling hard disk drive with ServeRAID SAS/SATA controller" on page 195).

Figure 62. Connect the mini-SAS cable to the storage tray

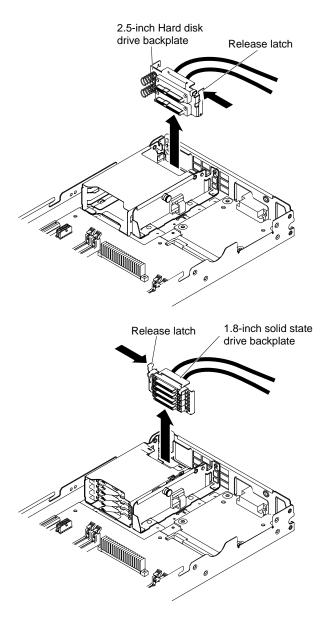
Figure 63. Removal of HDD backplate for 2.5-inch and 1.8-inch respectively

- Step 1. Remove the cover (see "Removing the compute node cover" on page 127).
- Step 2. Unlatch and slide out slightly the easy-swap hard disk drive and hard disk drive bay filler, (just enough to disengage the drive or filler).
- Step 3. Unlatch the release latch and lift out the hard disk drive backplate.

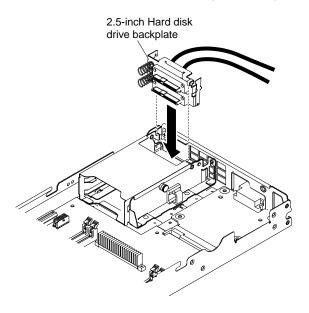
Figure 64. Installing backplate for 2.5-inch

- Step 1. Remove the cover (see "Removing the compute node cover" on page 127).
- Step 2. Align the backplate with the hard disk drive cage and the connector on the system board and press the backplate into position until it is fully seated in the connector.
- Step 3. Close the release latch.
- Step 4. Slide the hard disk drive into the bay until it is firmly seated in the connector.

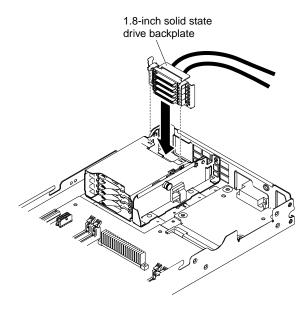
Figure 65. Installing backplate for 1.8-inch

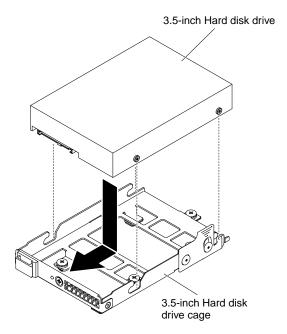
- Step 1. Read "Safety" on page v and "Installation guidelines" on page 111.
- Step 2. If the compute node is installed in an Lenovo NeXtScale n1200 Enclosure, remove it (see "Removing a compute node from a chassis" on page 114 for instructions).
- Step 3. Carefully lay the compute node on a flat, static-protective surface, orienting the compute node with the bezel pointing toward you.
- Step 4. Remove the cover (see "Removing the compute node cover" on page 127).
- Step 5. Remove the filler panel, if one is present.
- Step 6. Touch the static-protective package that contains the disk drive to any unpainted metal surface on the server; then, remove the disk drive from the package and place it on a static-protective surface.
- Step 7. Align the drive with the guide rails in the bay; then, carefully slide the drive assembly into the drive bay until the drive snaps into place.

Figure 67. 3.5-inch hard disk drive installation

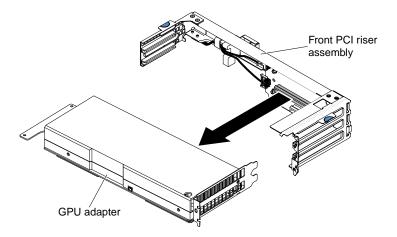
Figure 87. GPU adapter removal (with front PCI riser assembly)

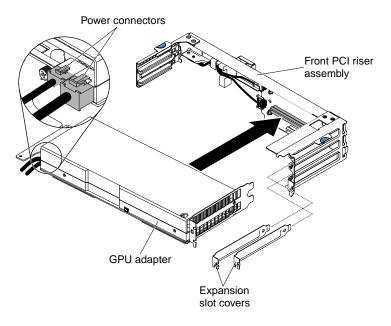
Figure 90. GPU adapter installation (with front PCI riser assembly)

Attention: When you install an adapter/GPU adapter, make sure that the adapter/GPU adapter is correctly seated in the riser-cage assembly and that the riser-cage assembly is securely seated in the riser-cage connector on the system board before you turn on the server. An incorrectly seated adapter might cause damage to the system board, the riser-cage assembly, or the adapter/GPU adapter.

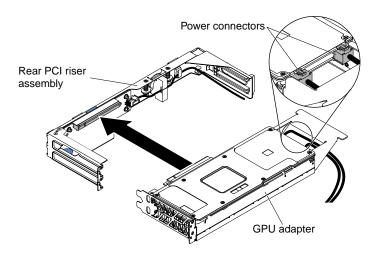
Figure 91. GPU adapter installation (with rear PCI riser assembly)

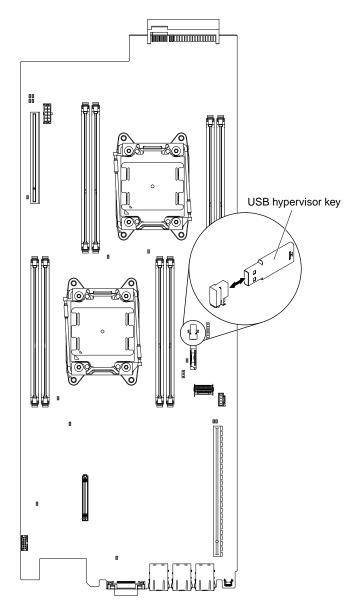
Figure 92. USB flash drive removal

- Step 1. Remove the cover (see "Removing the compute node cover" on page 127).
- Step 2. Locate the USB connector on the system board (see "System-board internal connectors" on page 15).
- Step 3. Pull the USB flash drive out of the connector.

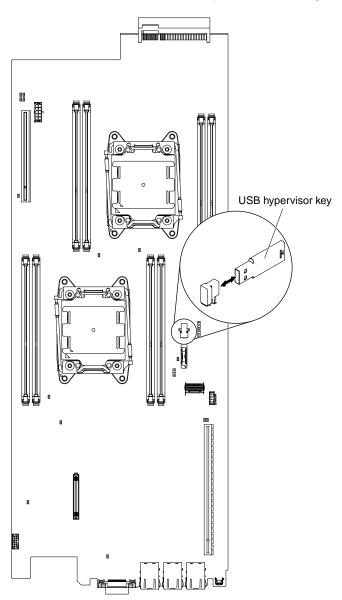
Figure 93. Installing USB flash drive

- Step 1. Remove the cover (see "Removing the compute node cover" on page 127).
- Step 2. Locate the USB connector on the system-board (see "System-board internal connectors" on page 15).
- Step 3. Push the USB flash drive into the connector.

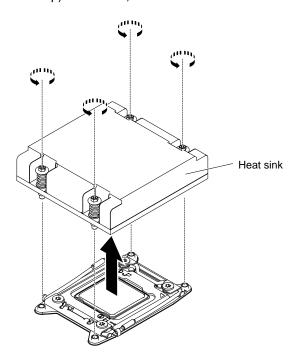
Figure 94. Heat sink removal

- a. Loosen the four screws on the corners of the microprocessor retainer.
- b. Lift the heat sink out of the server. After removal, place the heat sink (with the thermal grease side up) on a clean, flat surface.

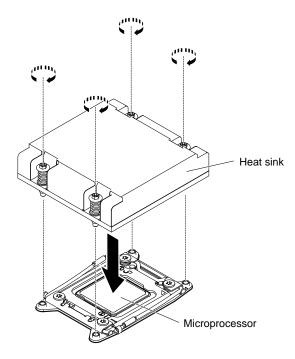
Figure 108. Heat sink installation

- a. Remove the plastic protective cover from the bottom of the heat sink.
- b. Position the heat sink over the microprocessor. The heat sink is keyed to assist with proper alignment.

- c. Align and place the heat sink on top of the microprocessor in the retention bracket, thermal material side down.
- d. Press firmly on the heat sink.
- e. Tighten the four screws on the corners of the microprocessor retainer
- Step 11. Reinstall the air baffle (see "Replacing the air baffle" on page 131).
- Step 12. Install the cover (see "Installing the compute node cover" on page 129).
- Step 13. Slide the server into the rack.
- Step 14. Reconnect the power cords and any cables that you removed.
- Step 15. Turn on the peripheral devices and the server.

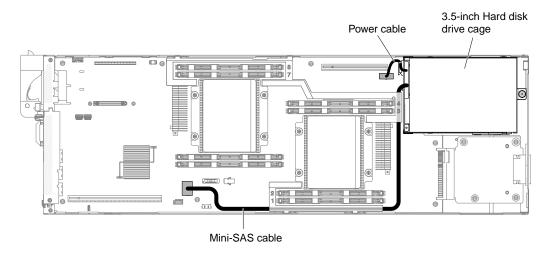
The following illustrations show the internal routing and connectors for the hard disk drive with software RAID signal cable.

Figure 111. 3.5-inch hard disk drive with software RAID signal cable connection

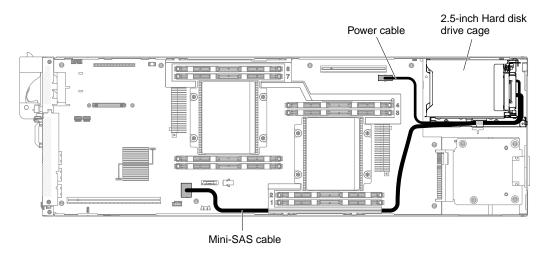
Figure 112. 2.5-inch hard disk drive with software RAID signal cable connection

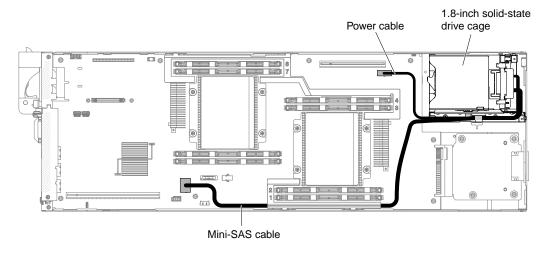
Figure 113. 1.8-inch hard disk drive with software RAID signal cable connection

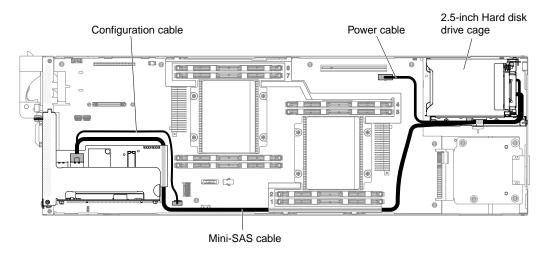
The following illustrations show the internal routing and connectors for the 2.5-inch and 1.8-inch hard disk drive models with ServeRAID SAS/SATA controller.

Figure 114. 2.5-inch hard disk drive with ServeRAID SAS/SATA controller cable connection

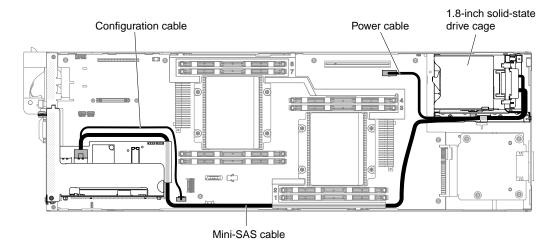
Figure 115. 1.8-inch hard disk drive with ServeRAID SAS/SATA controller cable connection
