System x3690 X5
Types 7147, 7148, 7149, and 7192
Problem Determination and Service Guide

Thirteenth Edition (October 2013)

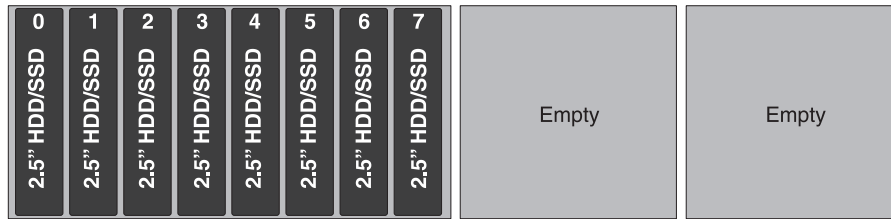
In the following illustration, the drive bay IDs are in sequential order because all of the drive backplanes are 2.5-inch backplanes:

For example, if the server has a 4x2.5-inch drive backplane and a 8x1.8-inch backplane configuration, the drive bay IDs for the four drives in the 4x2.5-inch drive backplane is 0 through 3. IMM assigns the drive bay IDs for the eight drives in the 8x1.8-inch drive backplane to start with an ID of 8 through 15. Since the drive bay IDs for the drives in the 4x2.5-inch backplane were 0 through 3, IMM reset the IDs by a gap of four (because the backplane supports four drives), then the drive IDs in the 8x1.8-inch drive backplane starts with an ID of 8 through 15. If a 8x2.5-inch drive backplane had been installed, instead of the 4x2.5-inch drive backplane, IMM would reset the IDs by a gap of eight, then the drive IDs for the drives in the 8x1.8-inch drive backplane would start at 16 through 23. See the following example illustrations and the illustrations in “Supported SAS/SATA drive backplane configurations” on page 122 for more information.

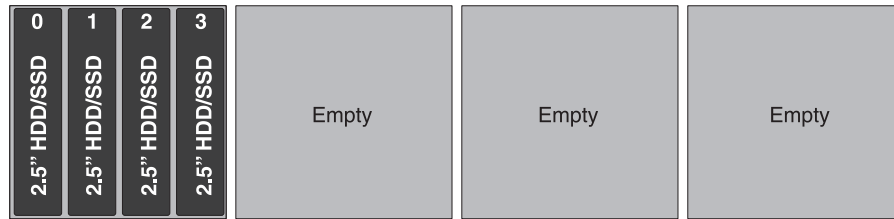
The following illustration shows the supported backplane configuration that you can use to support four drives:

This configuration consists of one 4x2.5-inch drive backplane and requires one SAS signal cable.

You can install a combination of 2.5-inch and 1.8-inch SAS/SATA drive backplanes in the server for the maximum drive capacity. However, any SAS/SATA adapter that you install in the server must be capable of supporting two internal, 4-lane SAS/SATA signal connectors. The following illustrations show the supported 2.5-inch and 1.8-inch SAS/SATA drive backplane configurations and drive IDs assigned by IMM:

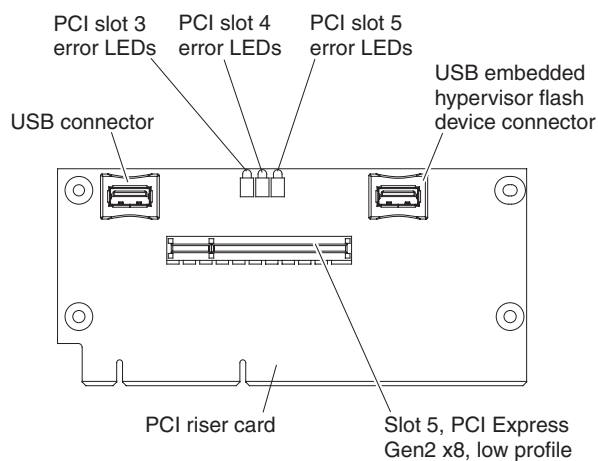
1. Read the safety information and installation guidelines, see “Safety” on page vii and “Installation guidelines” on page 97.
2. Turn off the server (see “Turning off the server” on page 19) and all attached peripheral devices. Disconnect all power cords; then, disconnect all external cables as necessary to replace the device.
3. Remove the top cover (see “Removing the server top cover” on page 100).
4. Locate the USB embedded hypervisor flash device connector on the one-slot side of the x8 low-profile riser-card as shown in the following illustration:
